CONSTRUCTION STORMWATER GENERAL PERMIT INSPECTION REPORT

State of Washington Department of Ecology

Ecology Inspector(s): Carol Serdar	On-Site Representative Name: Thom Fischer Title: Electron Hydro LLC, permittee	Inspection Date and Entry/Exit Time: 21 Sept 2020, 9:00/14:00	Inspection Type: ERTS and CSWGP review
Contaminated CSWGP Inspector Phone: 360.742.9751 Email: carolserdar@ecy.wa.gov	Additional Participants:	Receiving waters: Puyallup River	Permit webpage: https://fortress.wa.gov/ecy/p/aris/FacilitySummary.aspx?FacilityId=70091

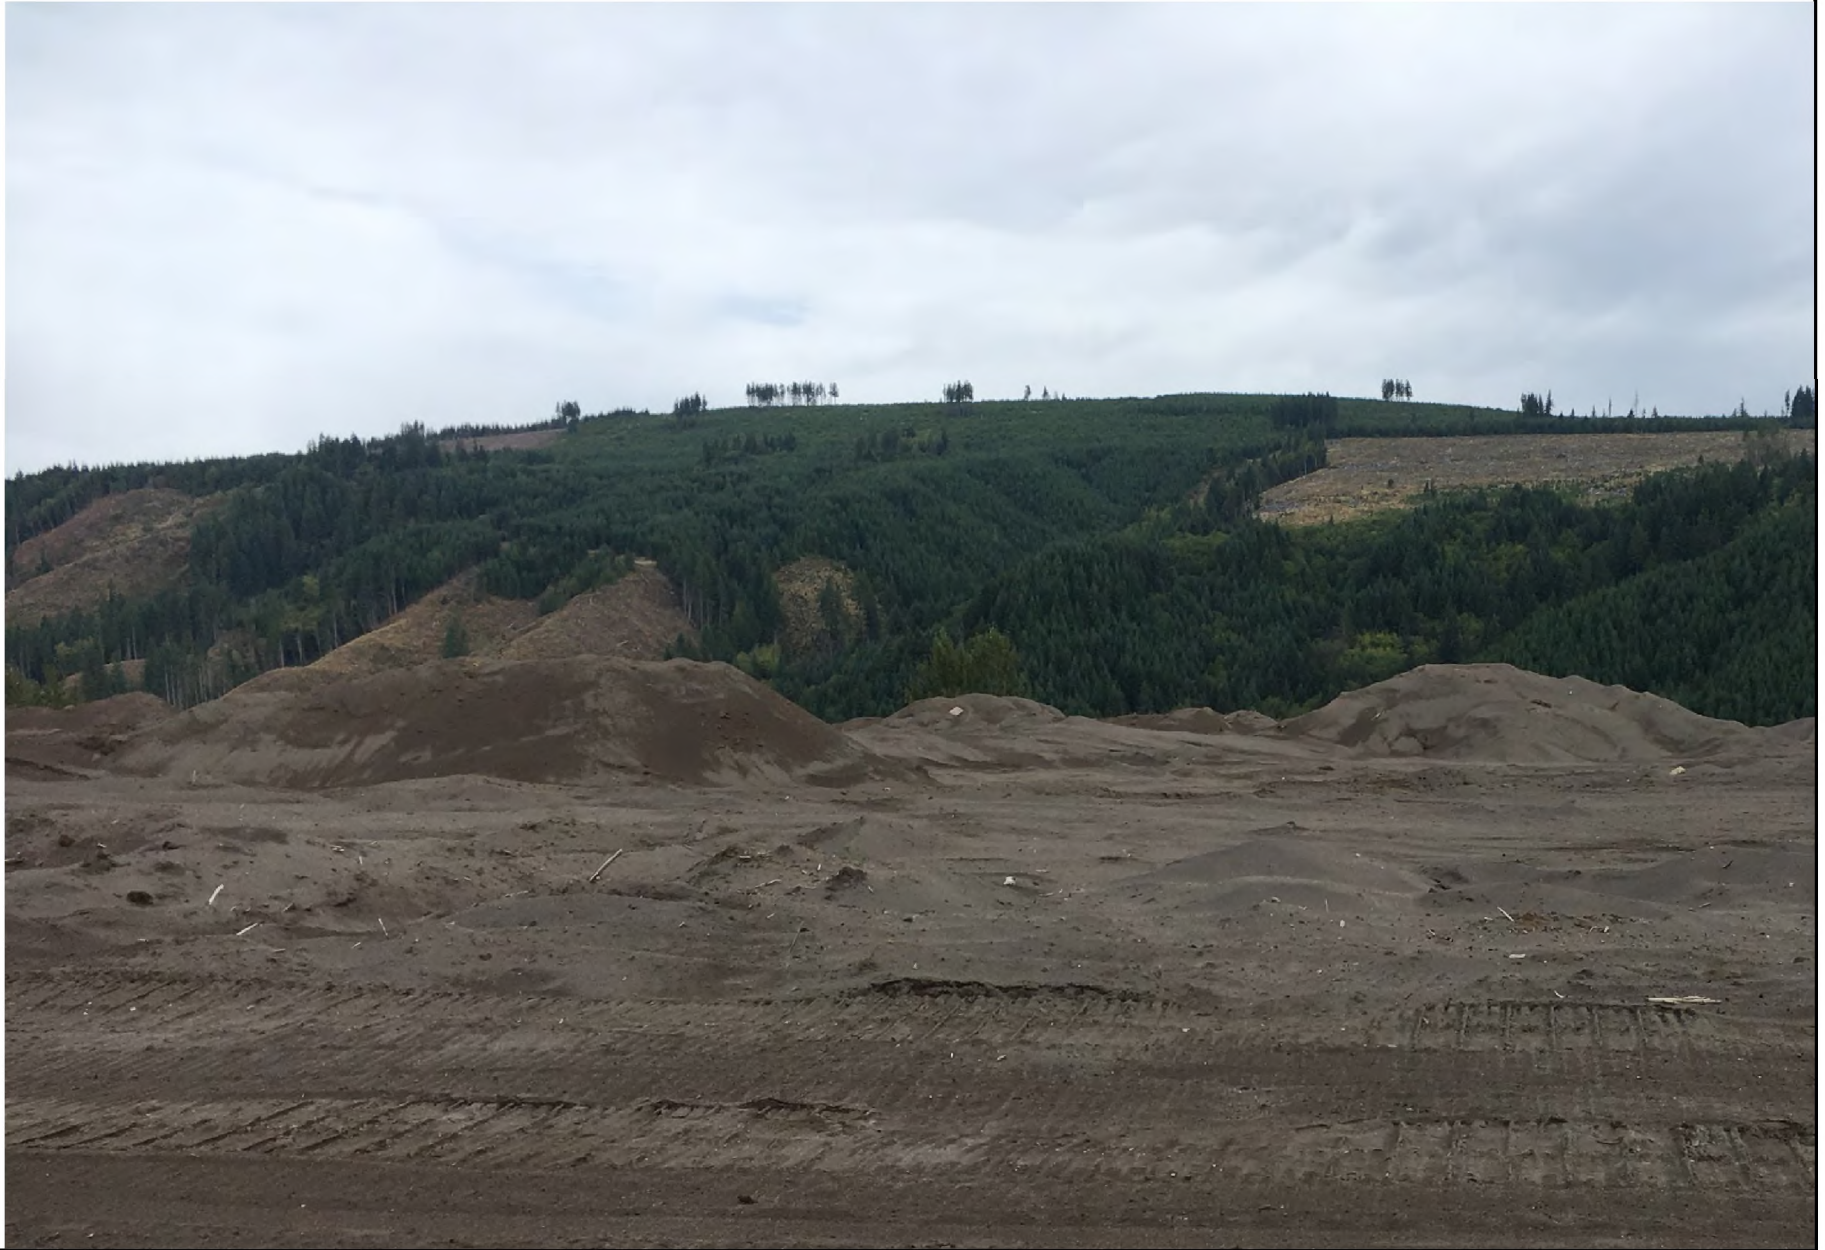
Photo 13

Photo Description: Settling Basin area – sandy to coarse sand sediment is fill adjacent to the settling basin. Photo was taken with back to settling basin.

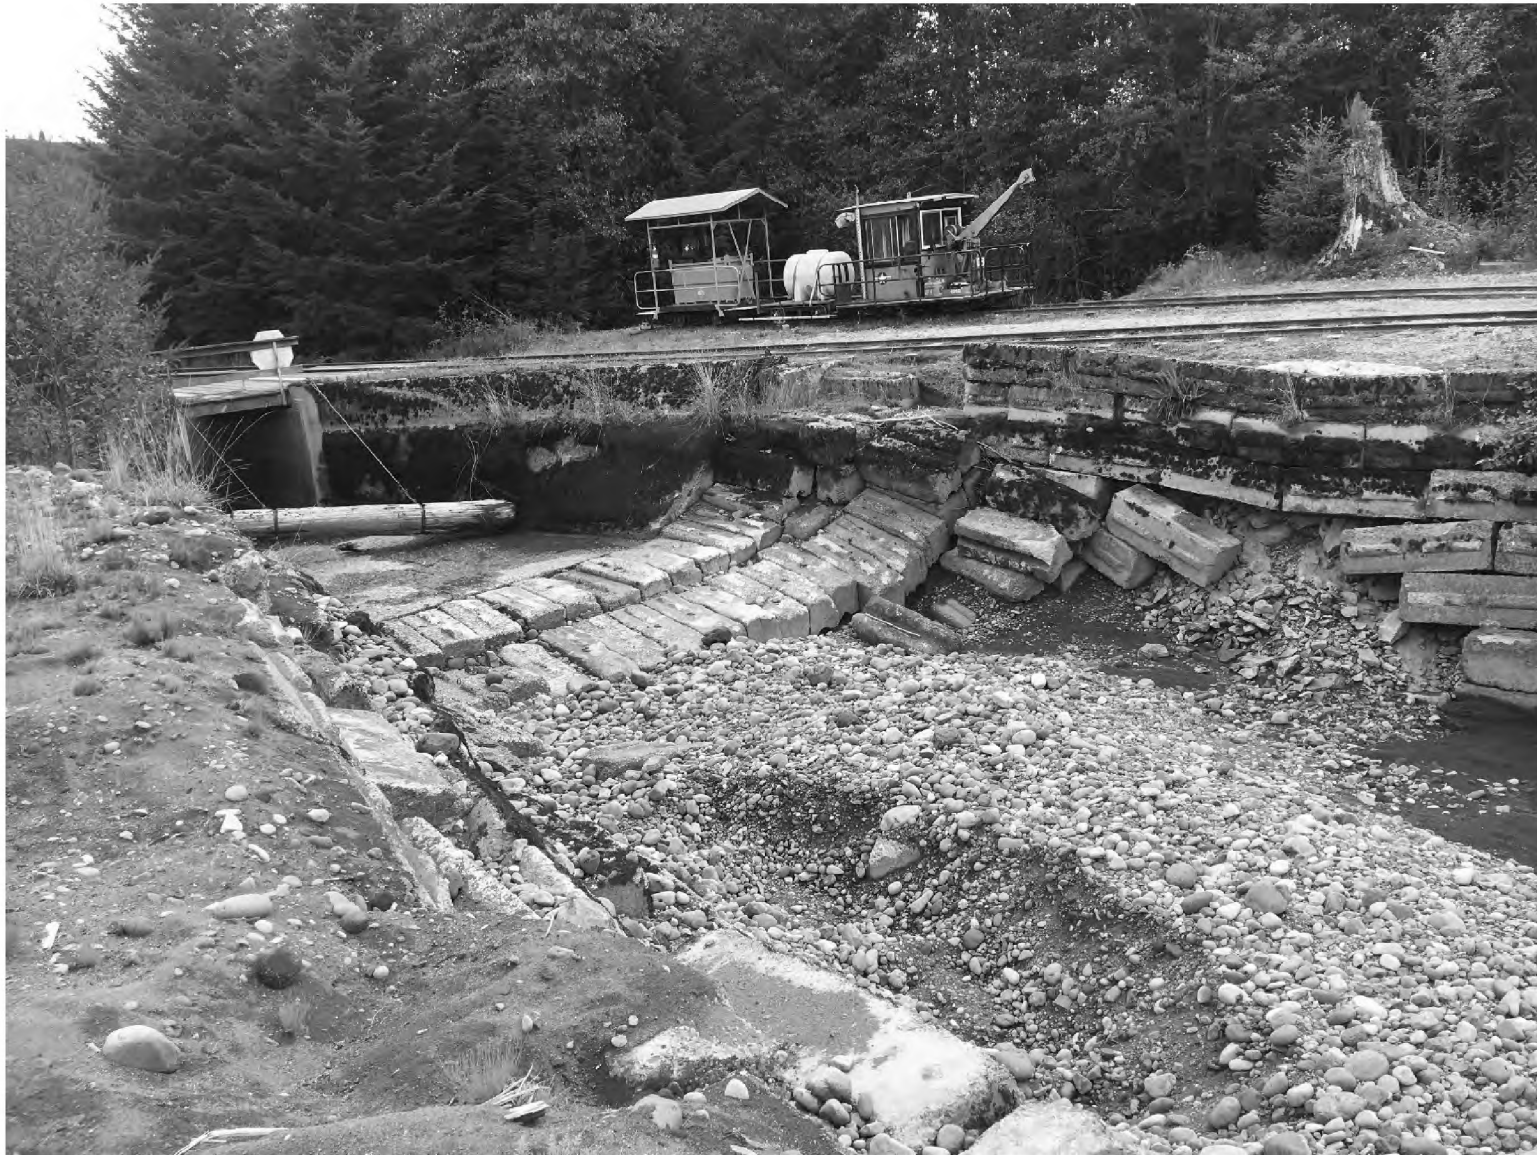
Photo 14

Photo Description: Settling Basin area – cobbles had dropped out of suspension; side wall needs repair, note the slumping of top of sidewall.

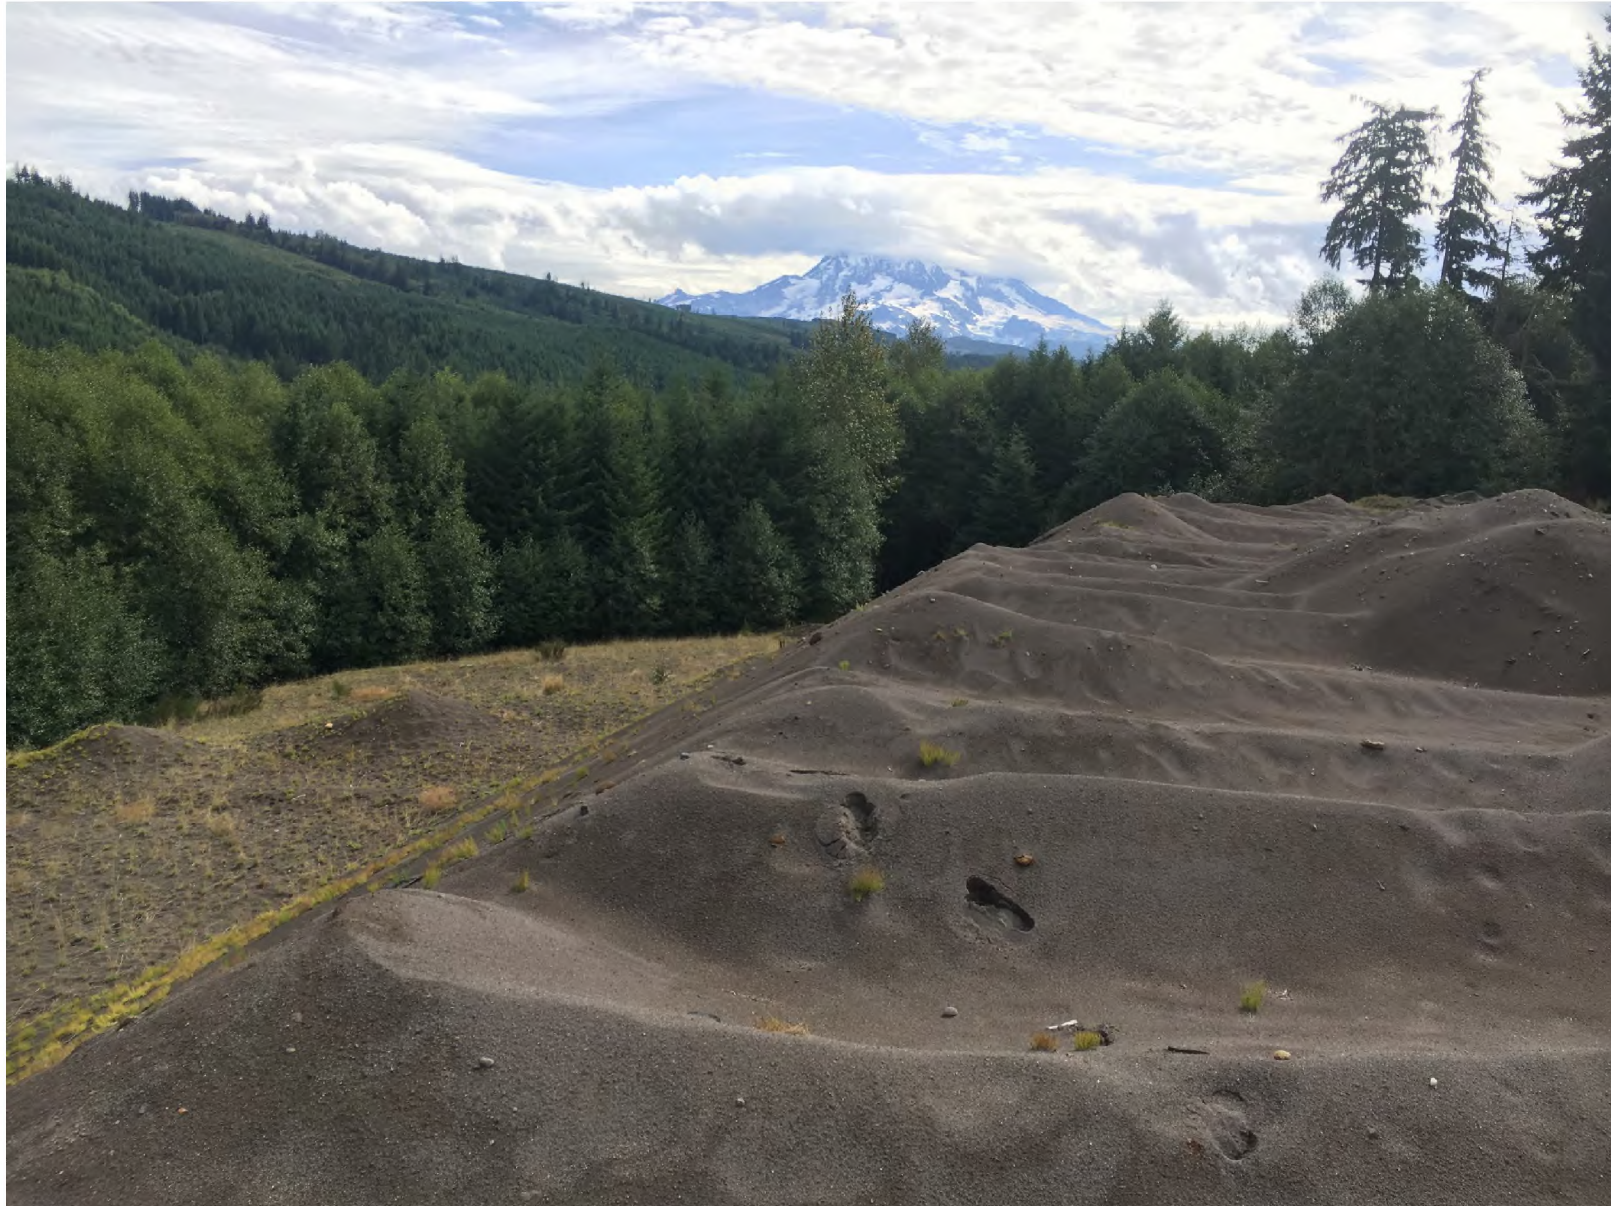
Photo 15

Photo Description: Settling Basin area – sandy to coarse sand sediment is filled adjacent to the settling basin.

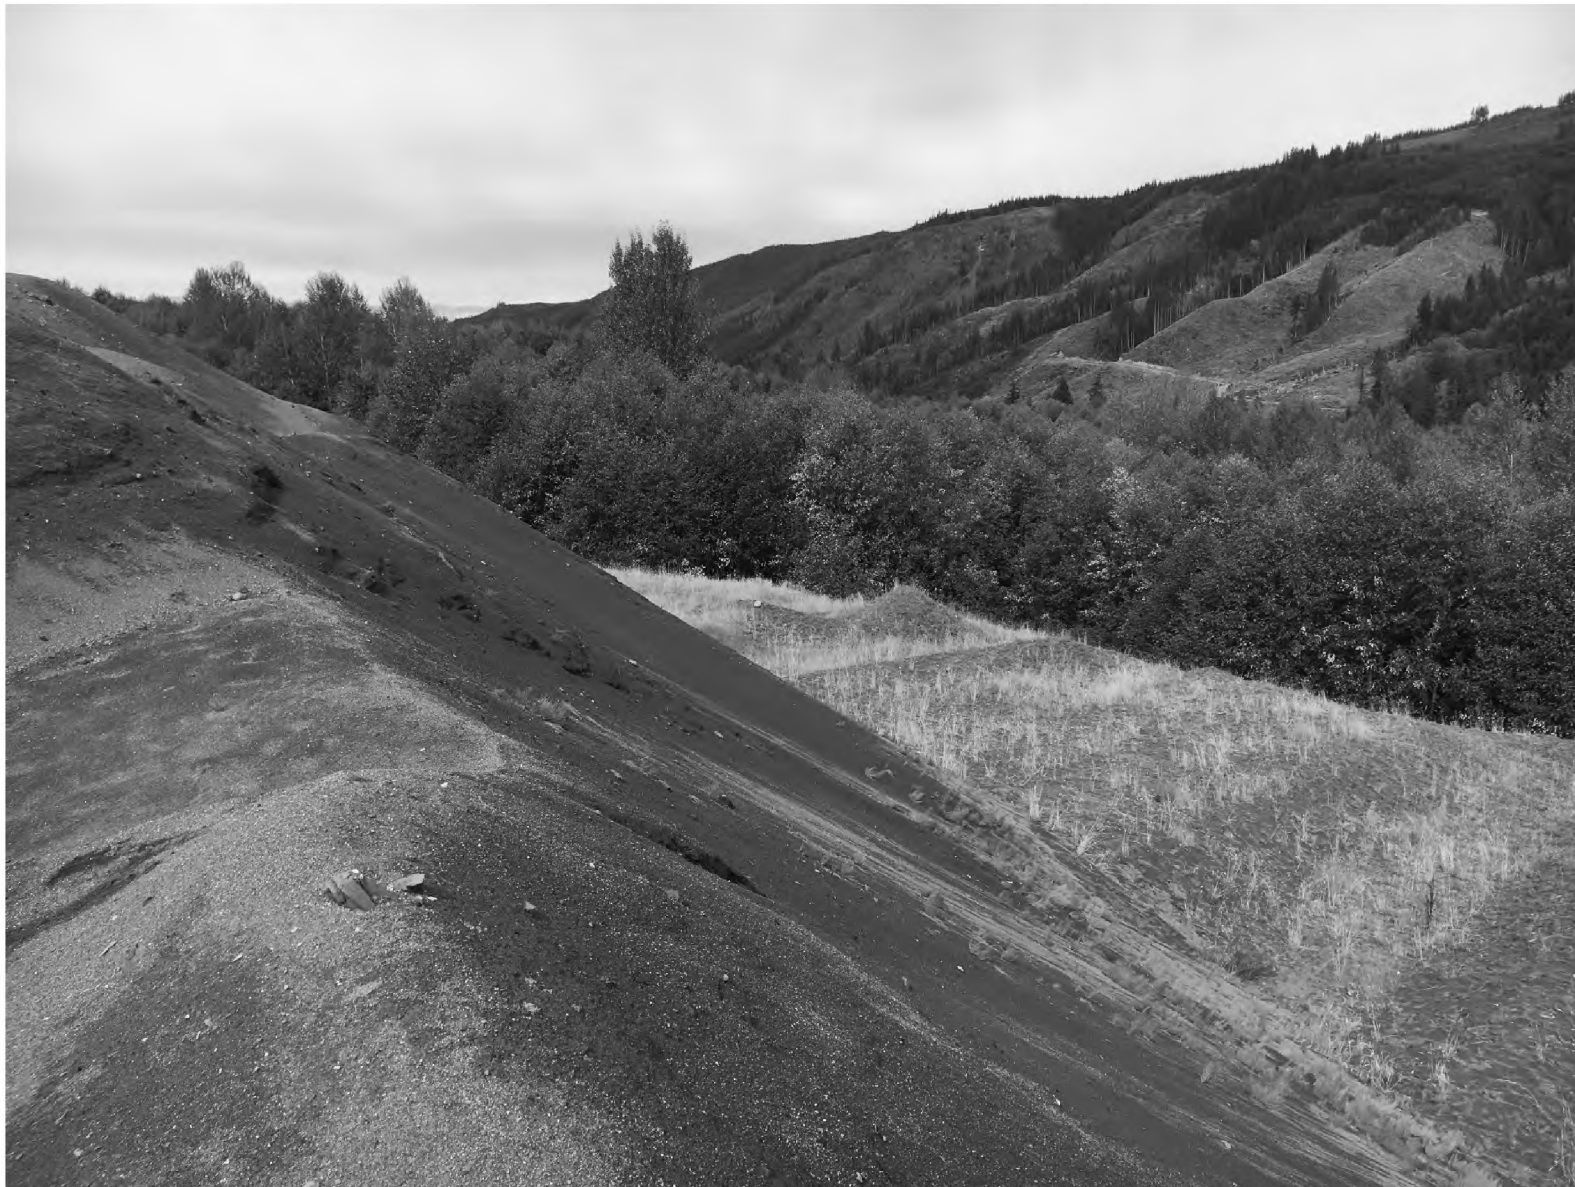
Photo 16

Photo Description: Settling Basin area – sandy to coarse sand sediment is filled adjacent to the settling basin. Puyallup River is in valley bottom.

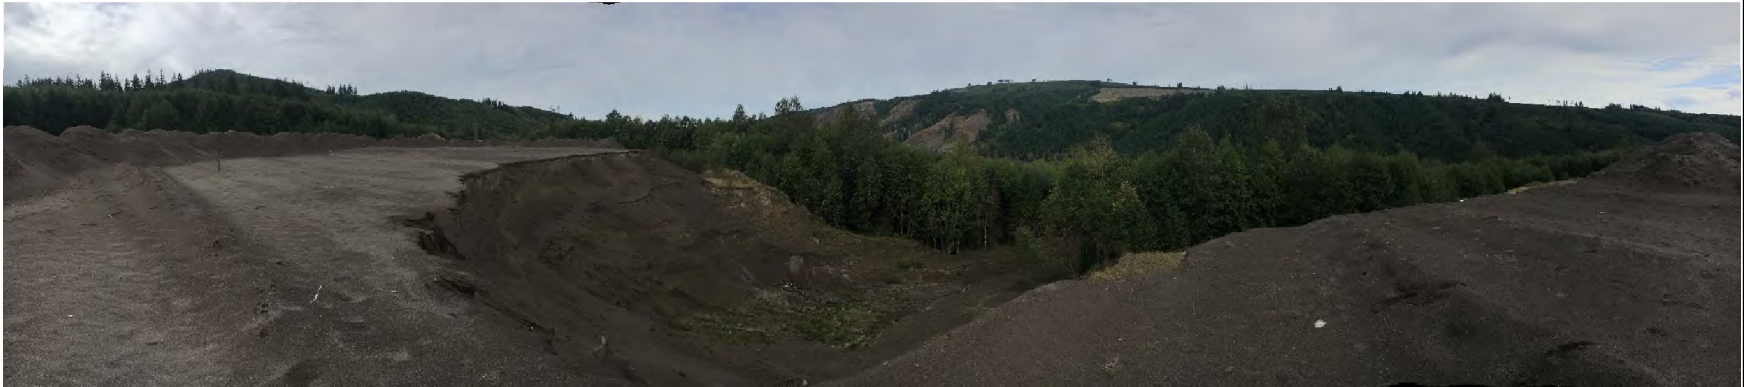
Photo 17

The area of filling is extensive and the edge has a very large, concave, deep-seated landslide that failed in January - February 2020 storm events. Thom was unsure if this failure discharged into the Puyallup River. Carol expressed that she will need to walk to the river, another day.

Photo Description: Settling Basin area – large deep-seated landslide, sandy to coarse sand sediment is filled adjacent to the settling basin. Panorama view.

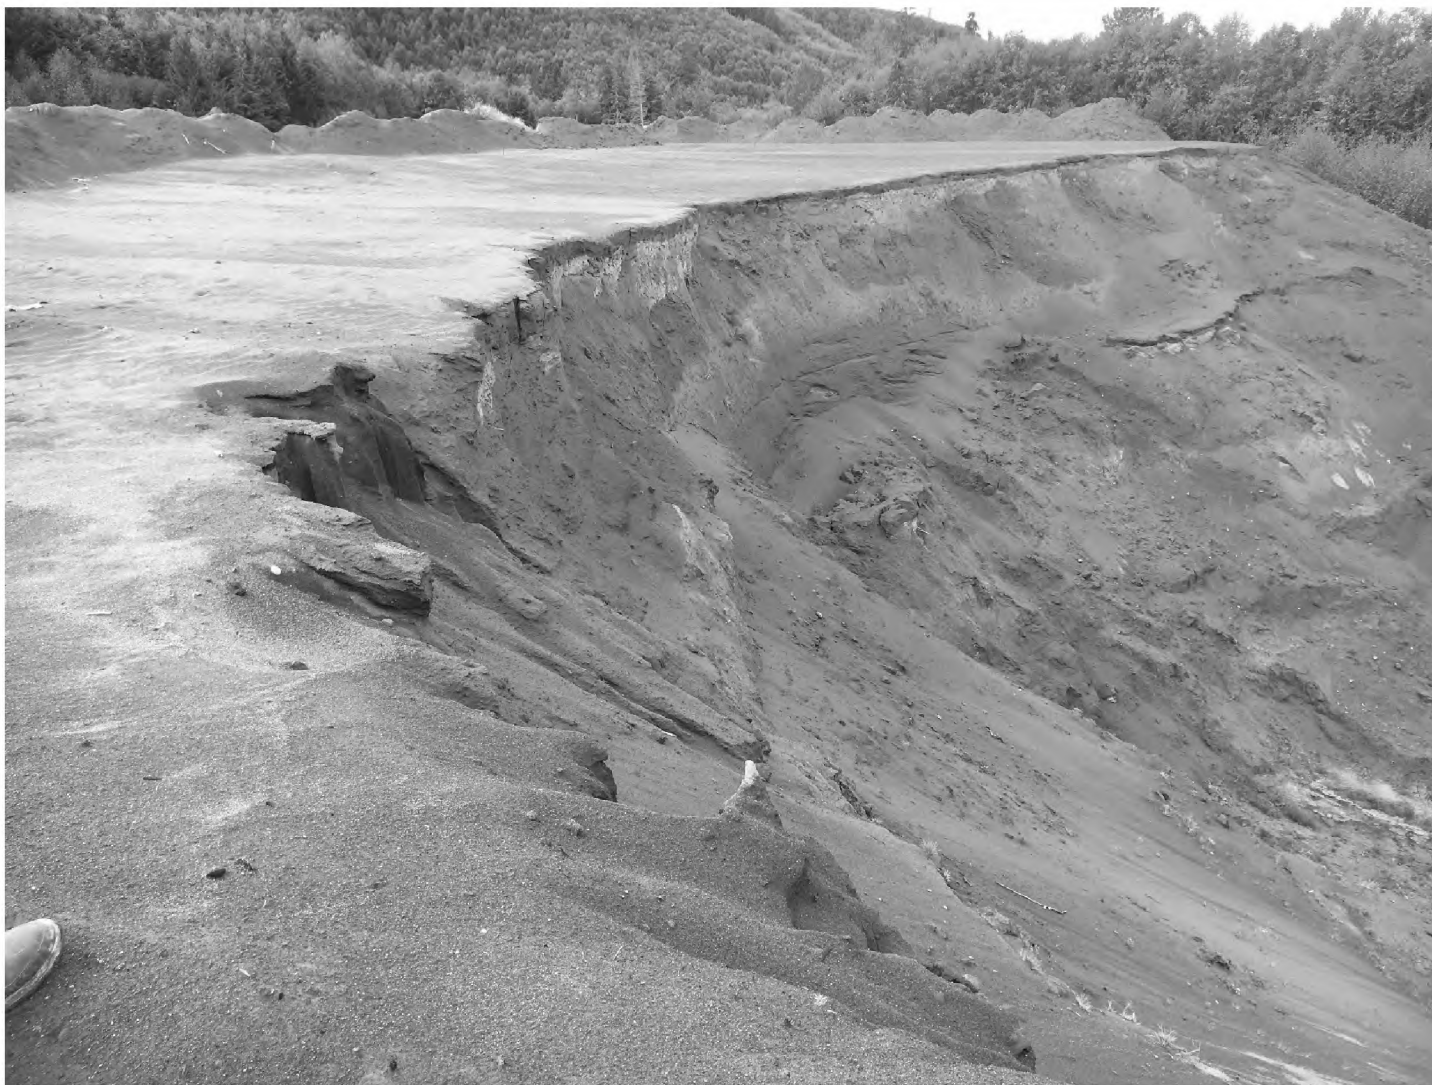
Photo 18

Photo Description: Settling Basin area – Sandy to coarse sand sediment is filled adjacent to the settling basin. Large deep-seated landslide, occurred during storms of Jan-Feb 2020; unsure if landslide delivered sediment to the Puyallup River. Carol will return to walk landslide deposit runout.

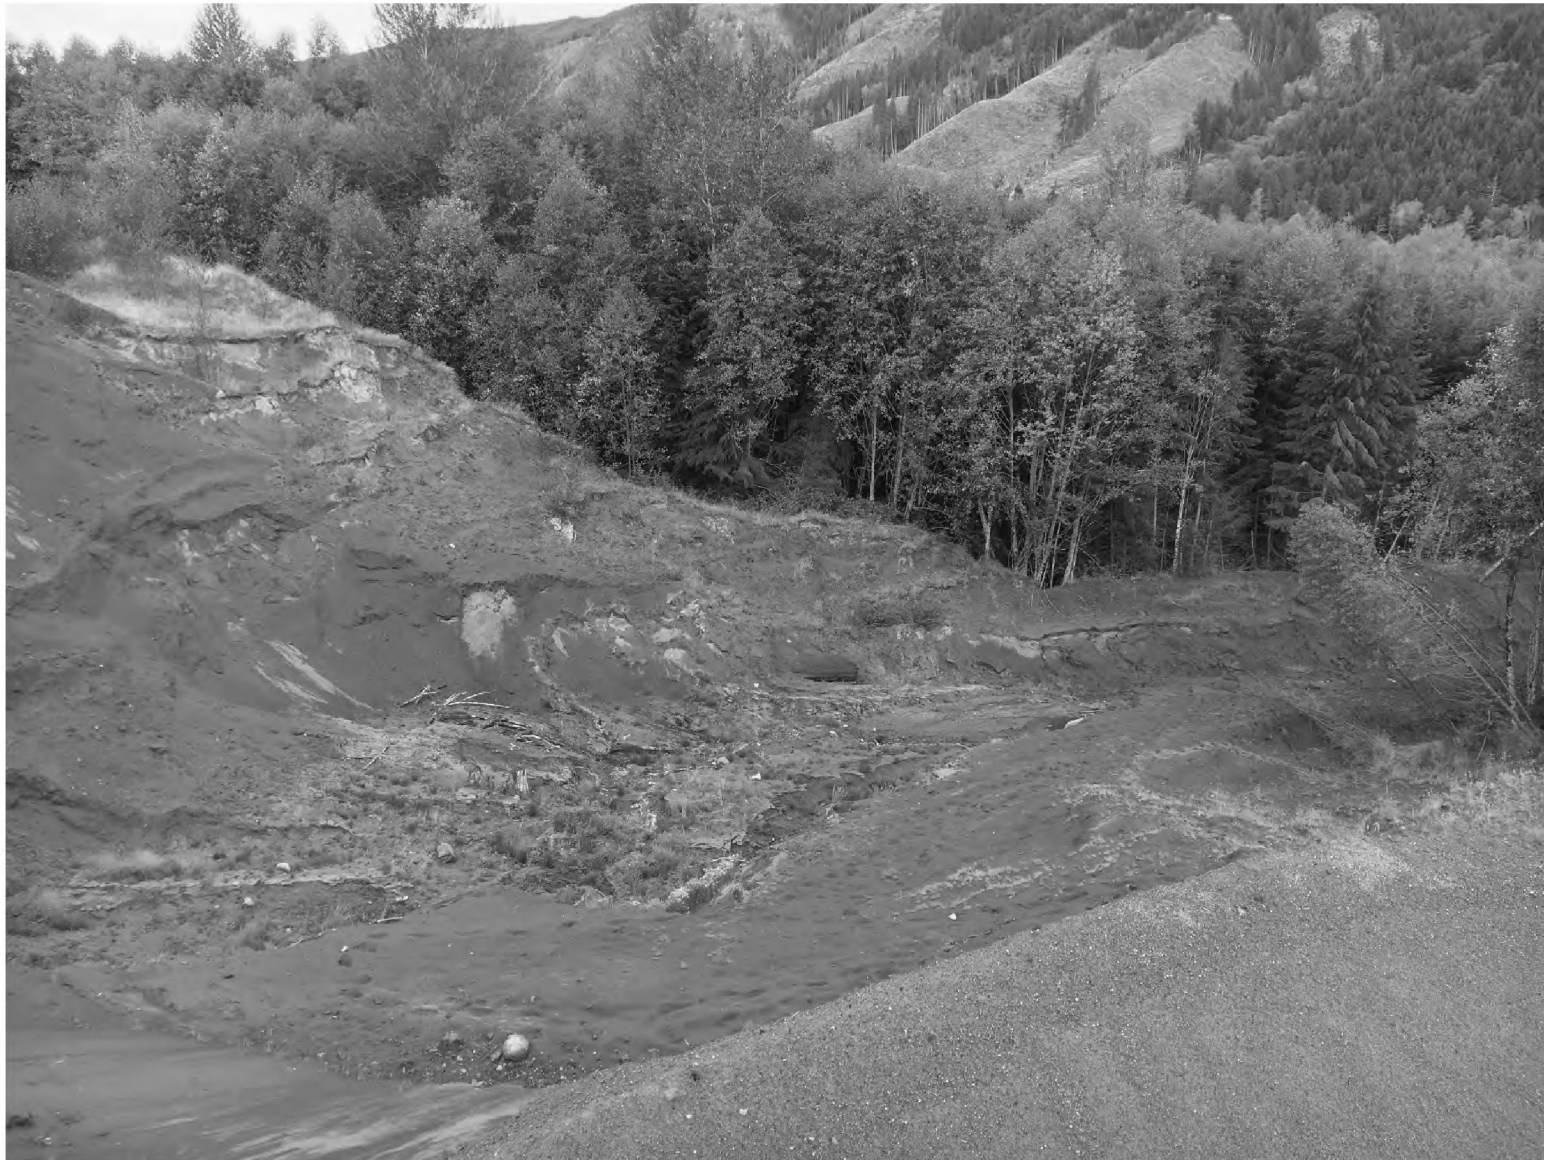
Photo 19

Photo Description: Settling Basin area – toe of large deep-seated landslide evacuated into forestland below, delivery to Puyallup River is unknown.

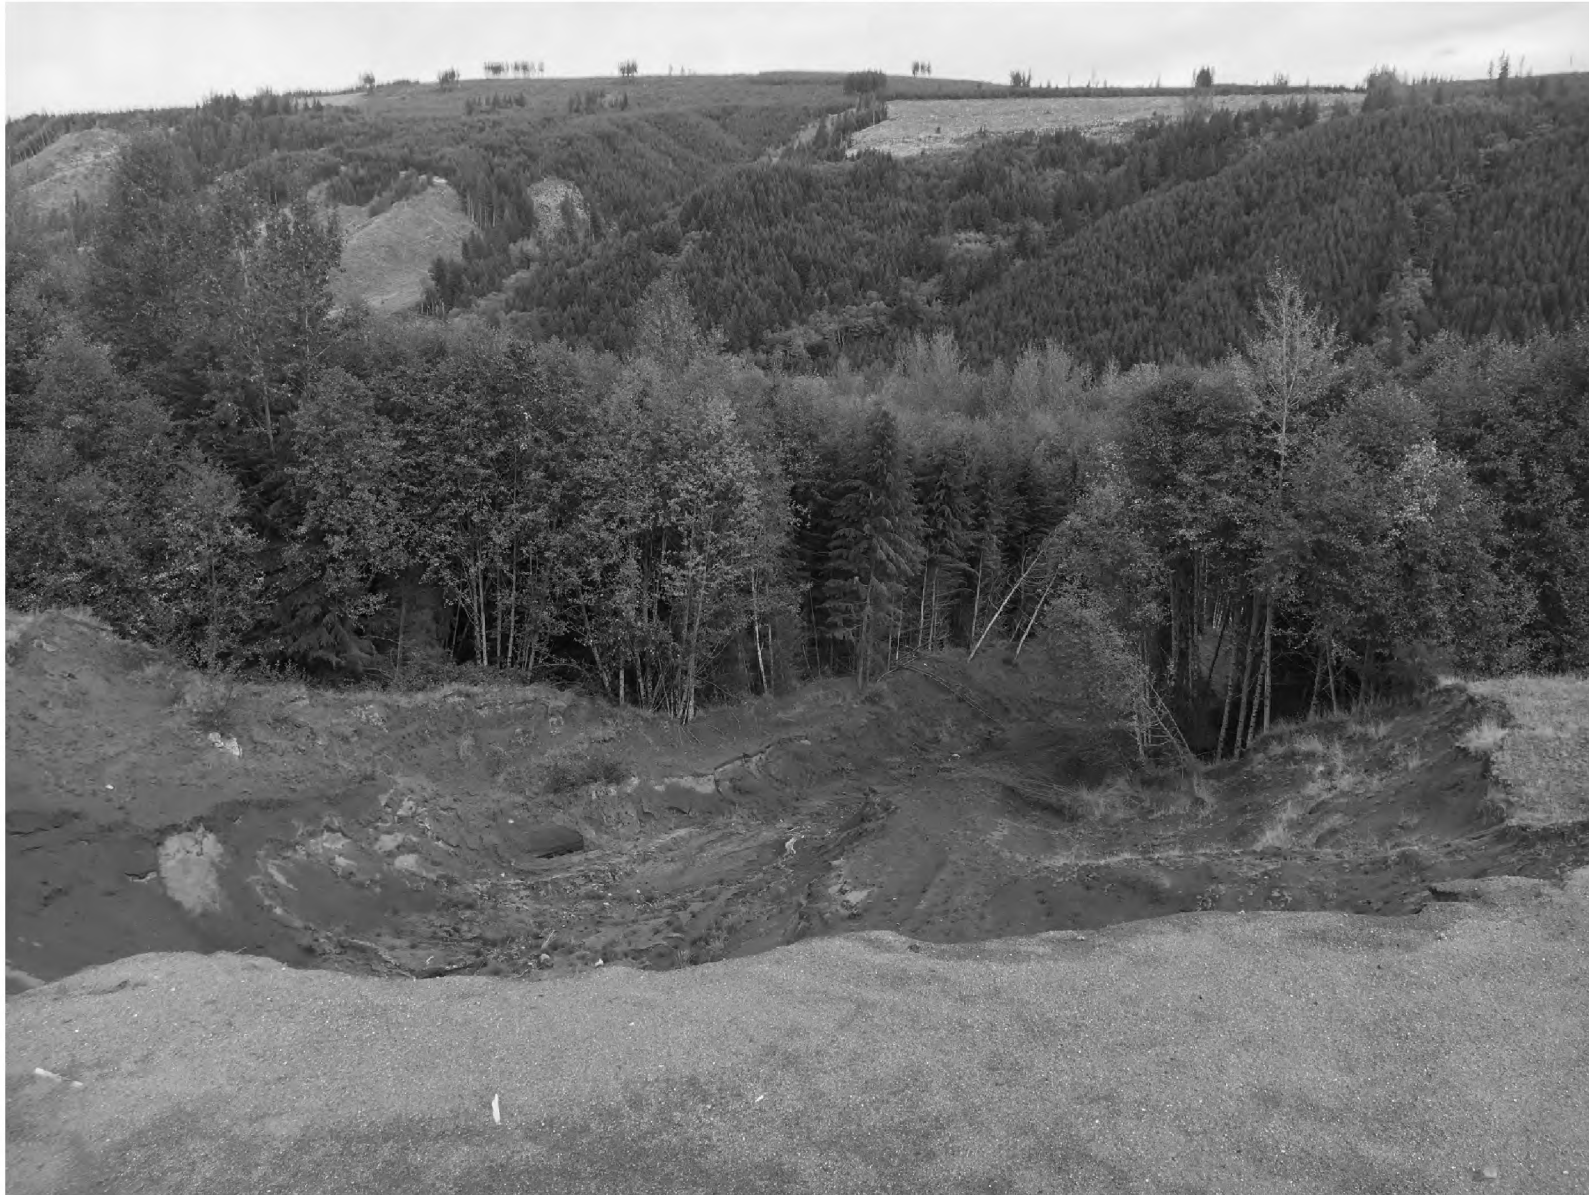
Photo 20

Photo Description: Settling Basin area – large deep-seated landslide, delivery to Puyallup River is unknown. Puyallup River is at bottom of valley.

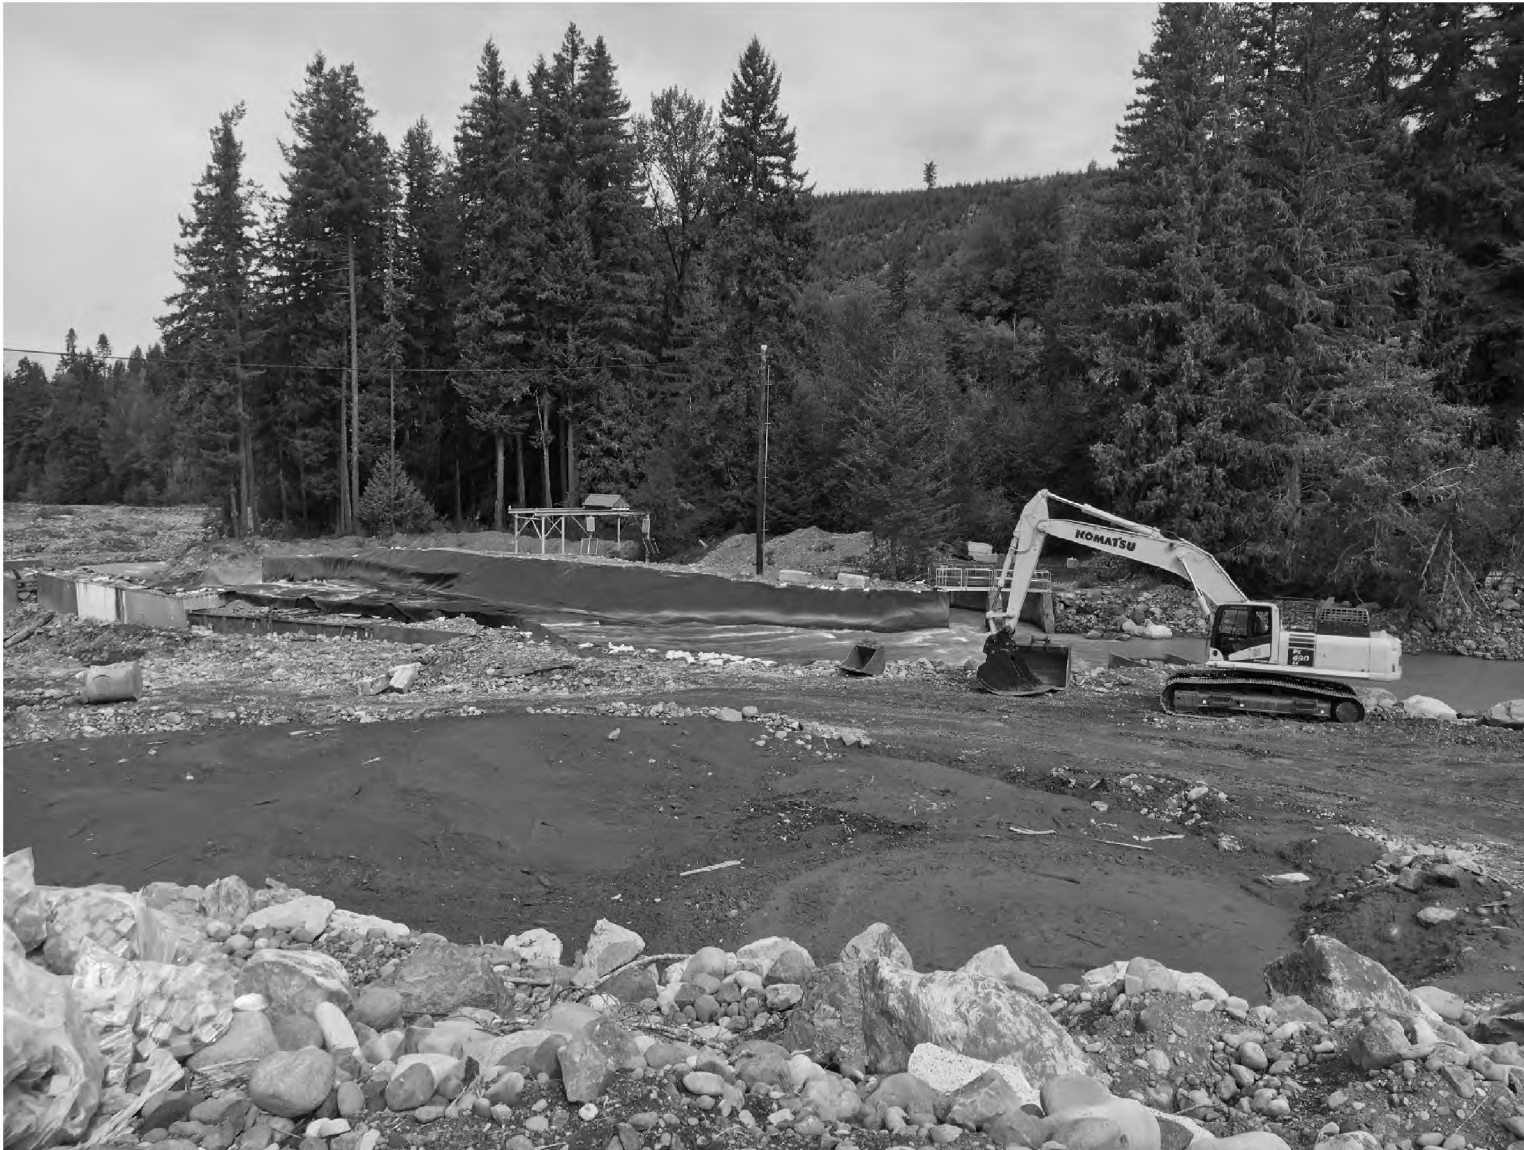
Photo 21

Photo Description: Intake Structure Construction area – looking downstream through construction area; river in by-pass channel in black liner, upstream end of fish ladder was seen right side of black liner.

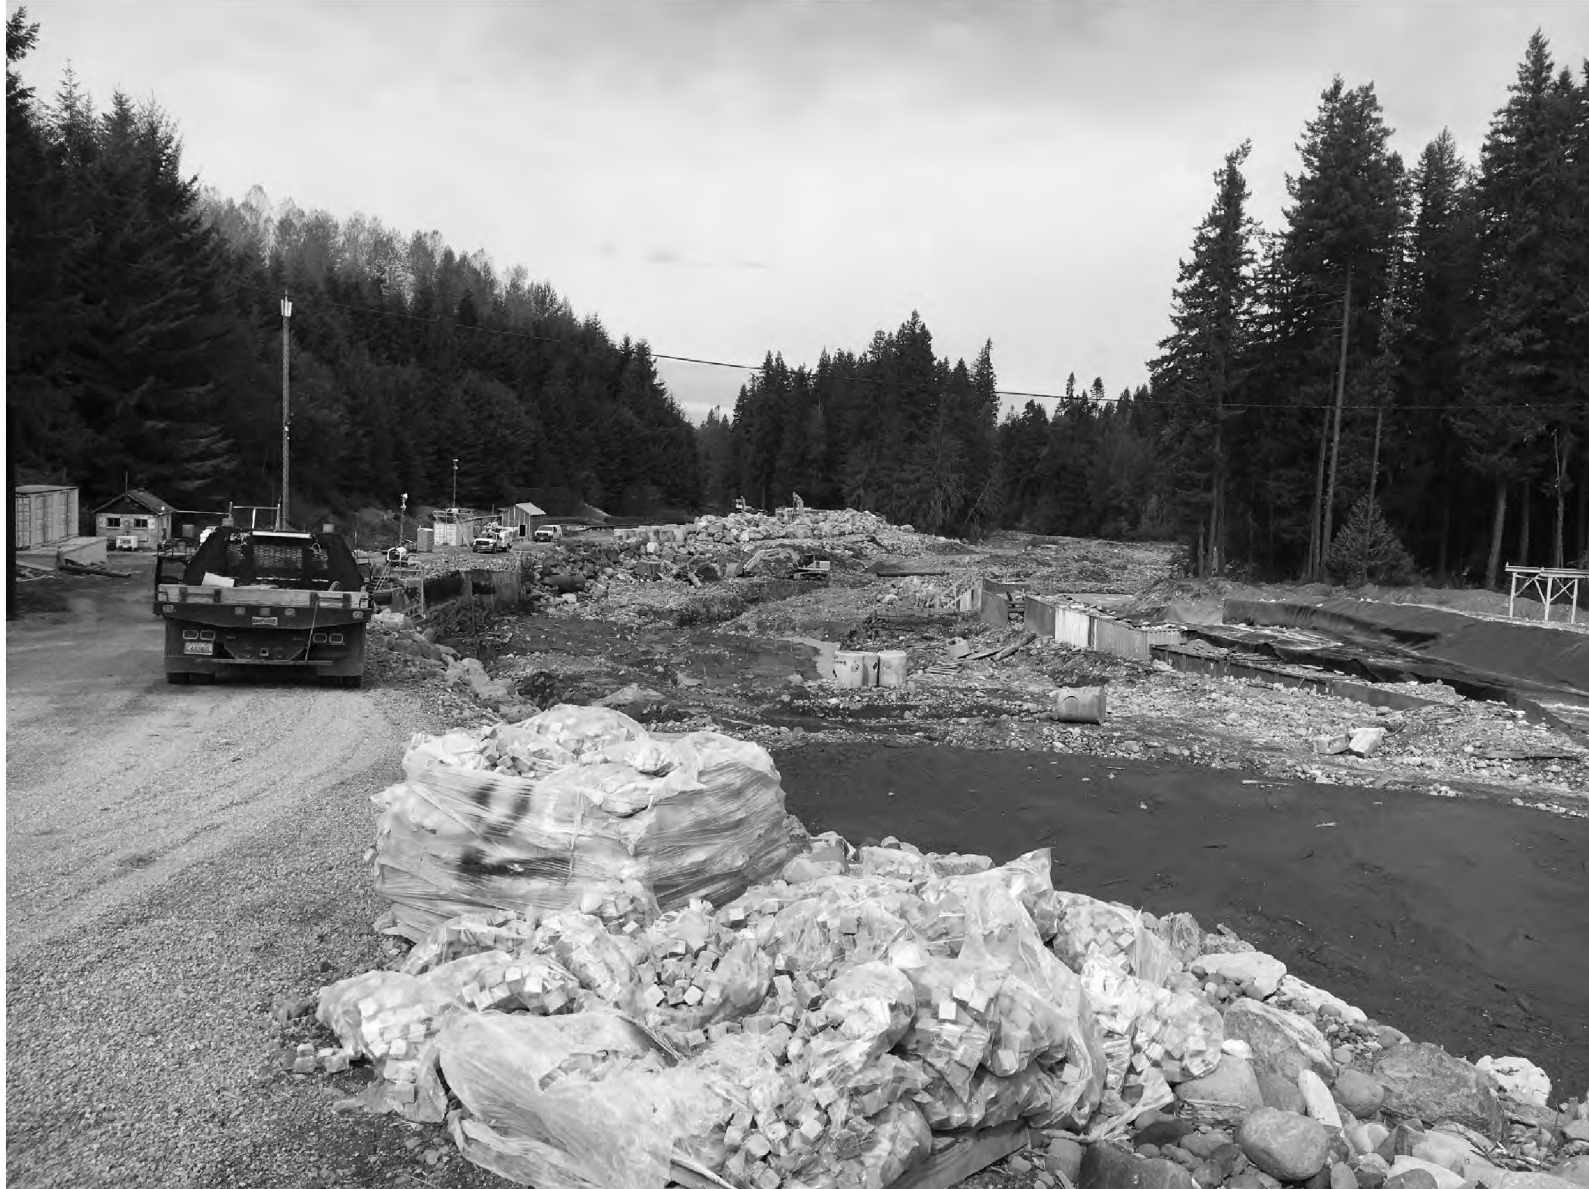
Photo 22

Photo Description: Intake Structure Construction area – looking downstream through construction area; river in by-pass channel in black liner.

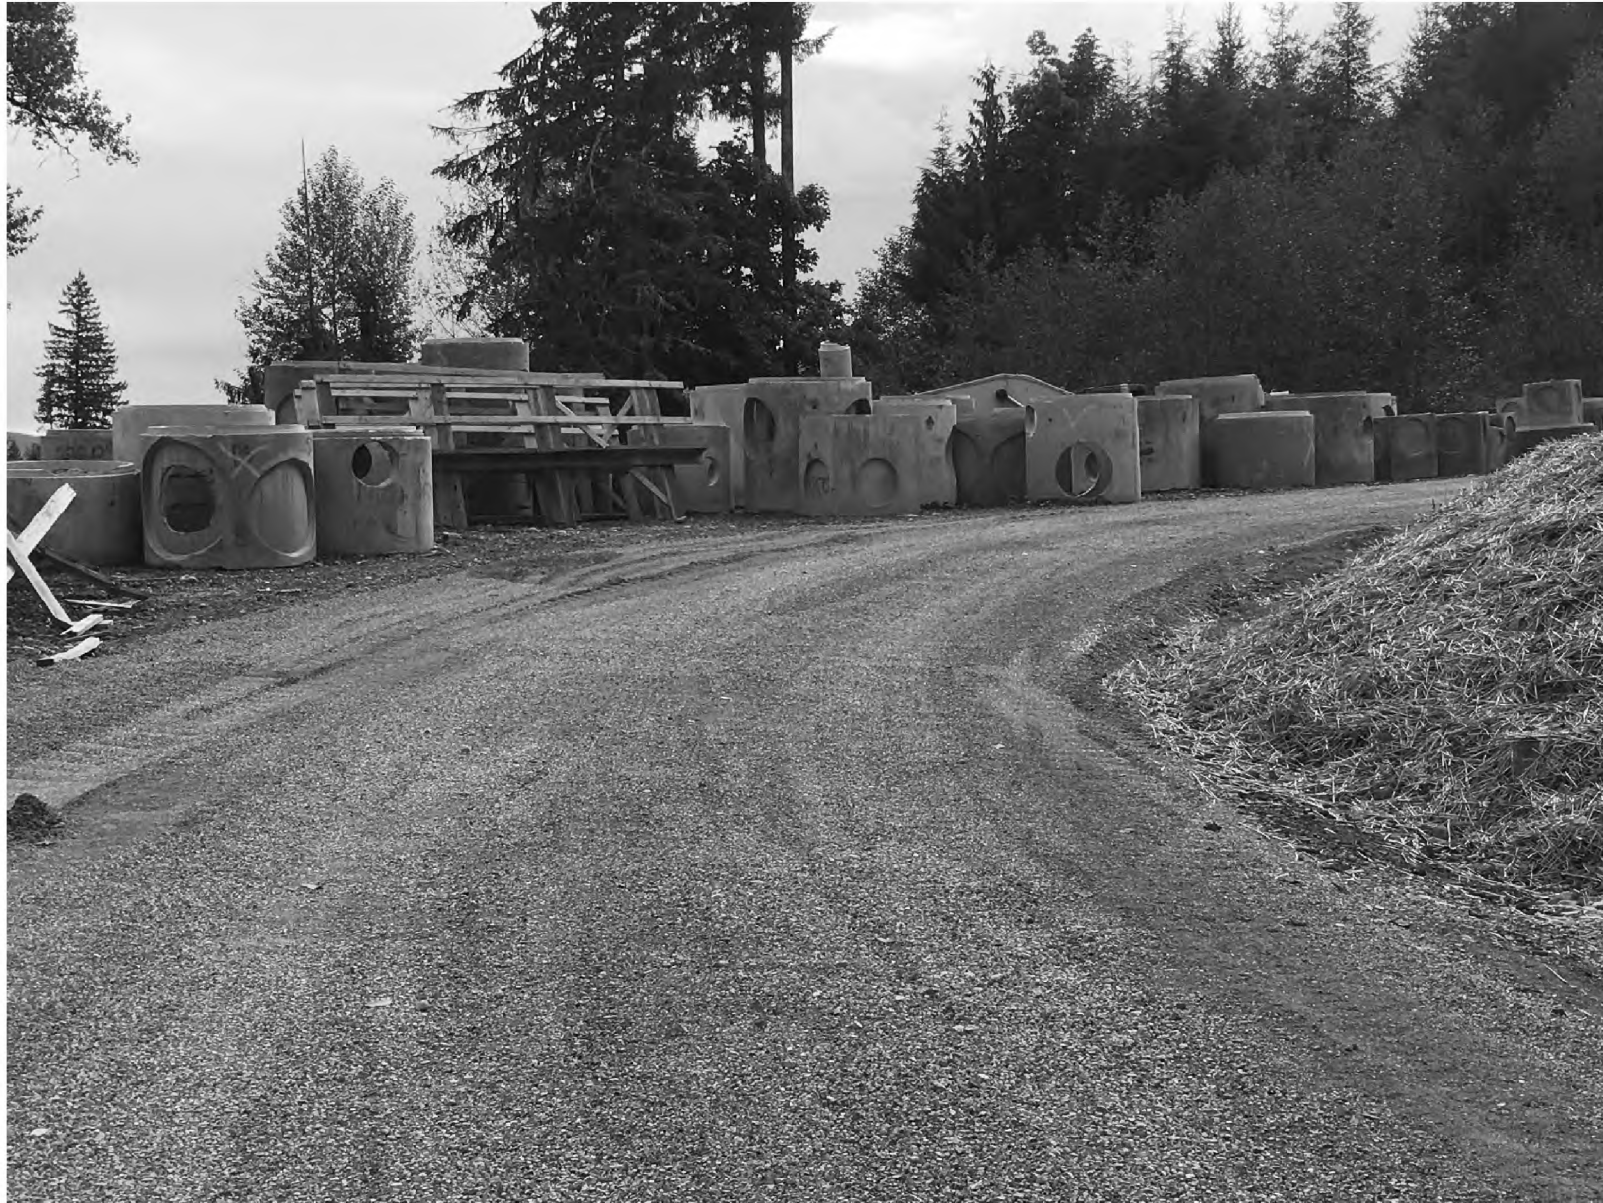
Photo 23

Haul road has been stabilized with gravel; adjacent slope to the intake structure had been previously exposed and unworked, has been stabilized with jute mat; discussed potential for need of additional BMP if stormwater rills the slope. Survey work of river bed was in progress. Discussed movement of rock and sediment used in construction around the site.

Photo Description: Intake Structure Construction area – gravel had been placed on the haul road; previously exposed and unworked side slope has been temporarily stabilized.

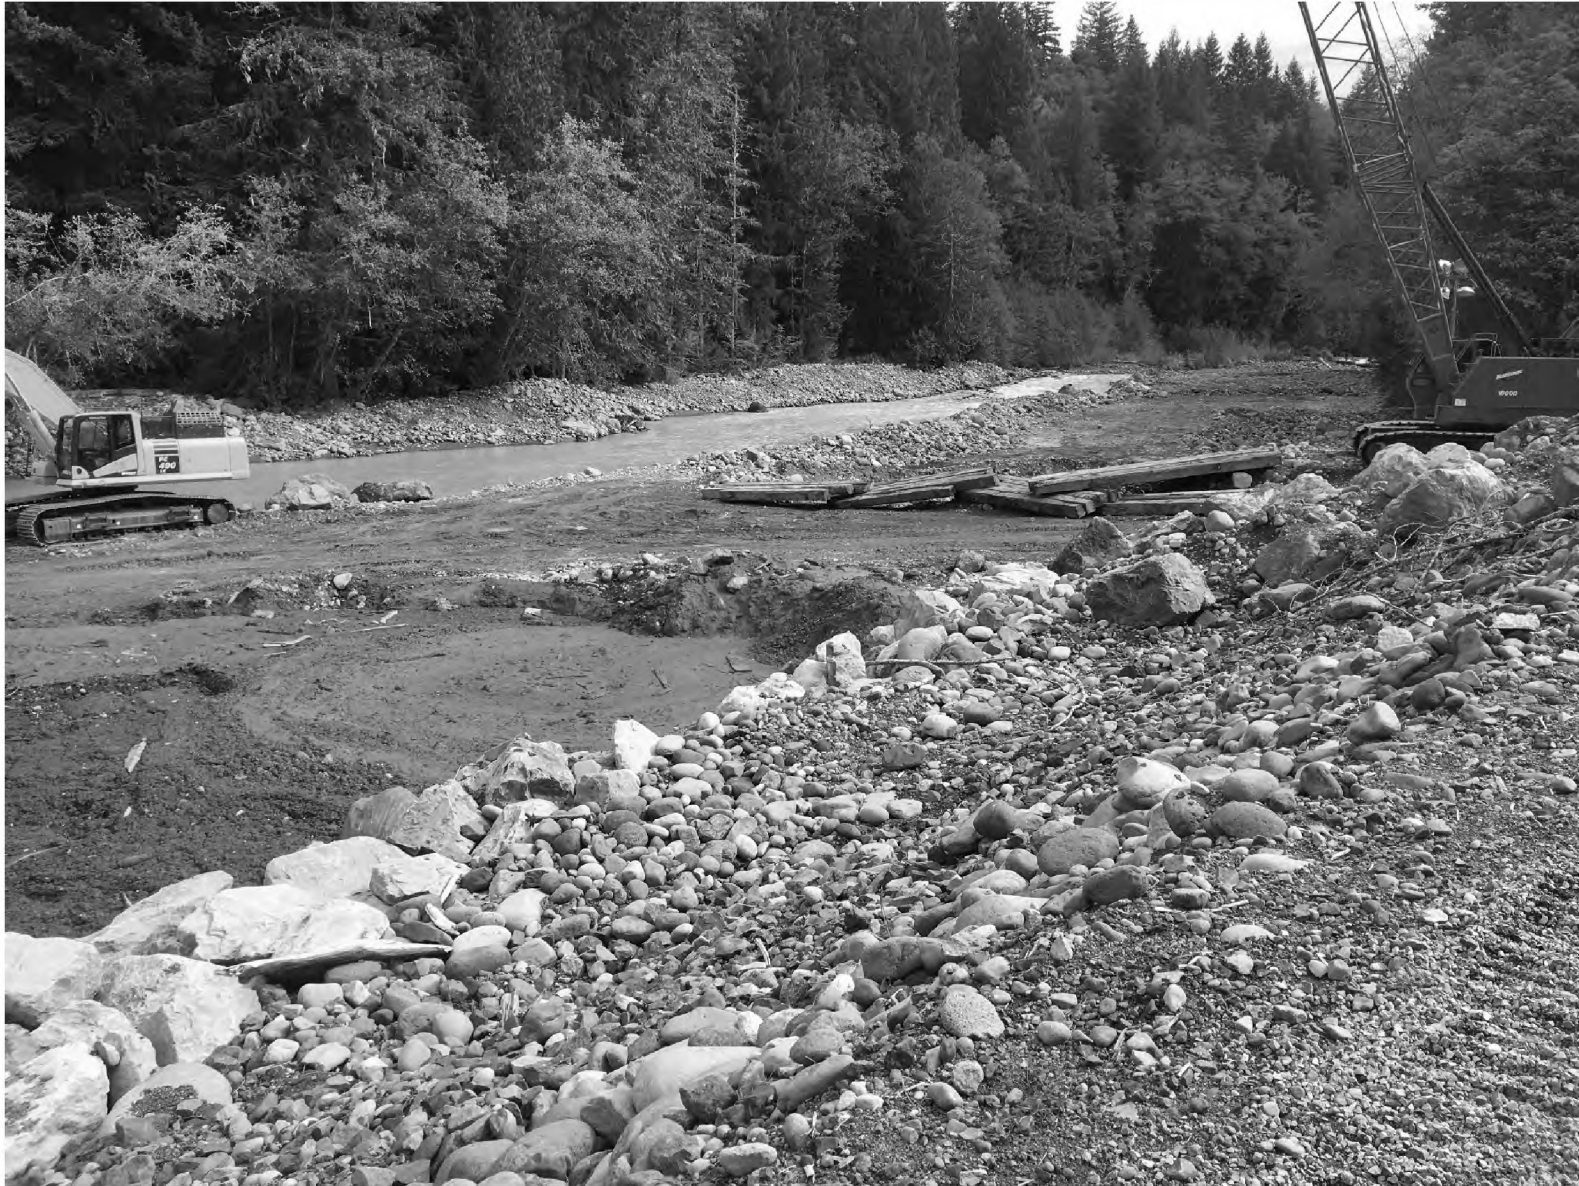
Photo 24

Photo Description: Intake Structure Construction area – upstream portion of construction area.
